RCRA Corrective Action Order Compliance Report

**Facility Name:** Former Rhone Poulenc Facility  
**Facility EPA ID#:** WAD 009282 2302  
**Facility Location:** 9229 East Marginal Way  
Seattle, WA  
**Facility Representatives:** John Ambrose, RCI Environmental  
Tasha Grey, Geomatrix  
Sarah Ruston, Geomatrix  
**Date of Inspection:** August 17, 2004  
**Date of Report:** September 9, 2004  
**Report Prepared by:** Shawn Blocker, *shawn 9/19/04*  
**Inspector(s):** Shawn Blocker, Environmental Scientist  
US Environmental Protection Agency  
1200 Sixth Avenue, WCM-126  
Seattle, WA 98101

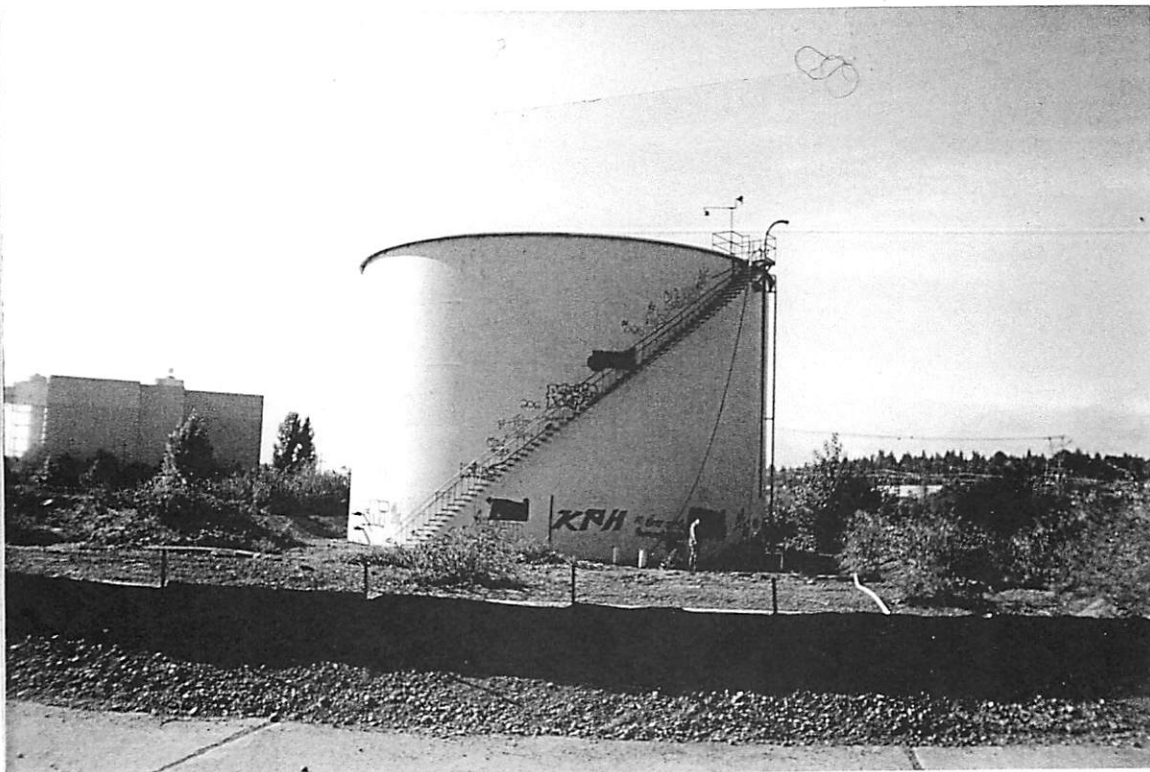
At this time I noticed 4 inch PVC piping on the ground near the large above ground storage tank located on site (photo 1). Upon further inspection, I found two different PVC lines originating from the tank. One line ("Line 1") was connected to a flex hose that went up the side of the tank completely to the top (photo 2 through 4). Line 1 proceeded from the tank in a northwestern direction across a containment berm, at which time it angled 45 degrees and ran directly east into the King County Sewer Lift Station (photo 5 and 6). I observed another portion of missing fence adjacent the lift station (photo 13). The other line ("Line 2") proceeded from near the bottom the tank directly north then turned 90 degrees terminating near the berm. After inspecting Line 2, I proceeded up the stairwell of the tank to the top. At the top, I observed that the flex line associated with Line 1 proceeded down into the tank and into several feet of liquid contained within the tank (photo 7 through 9). The hose was hooked to a submersible pump (photo 9). After observing this I proceeded down the stairs toward the access gate adjacent the Duwamish waterway.

1. Above ground storage tank.

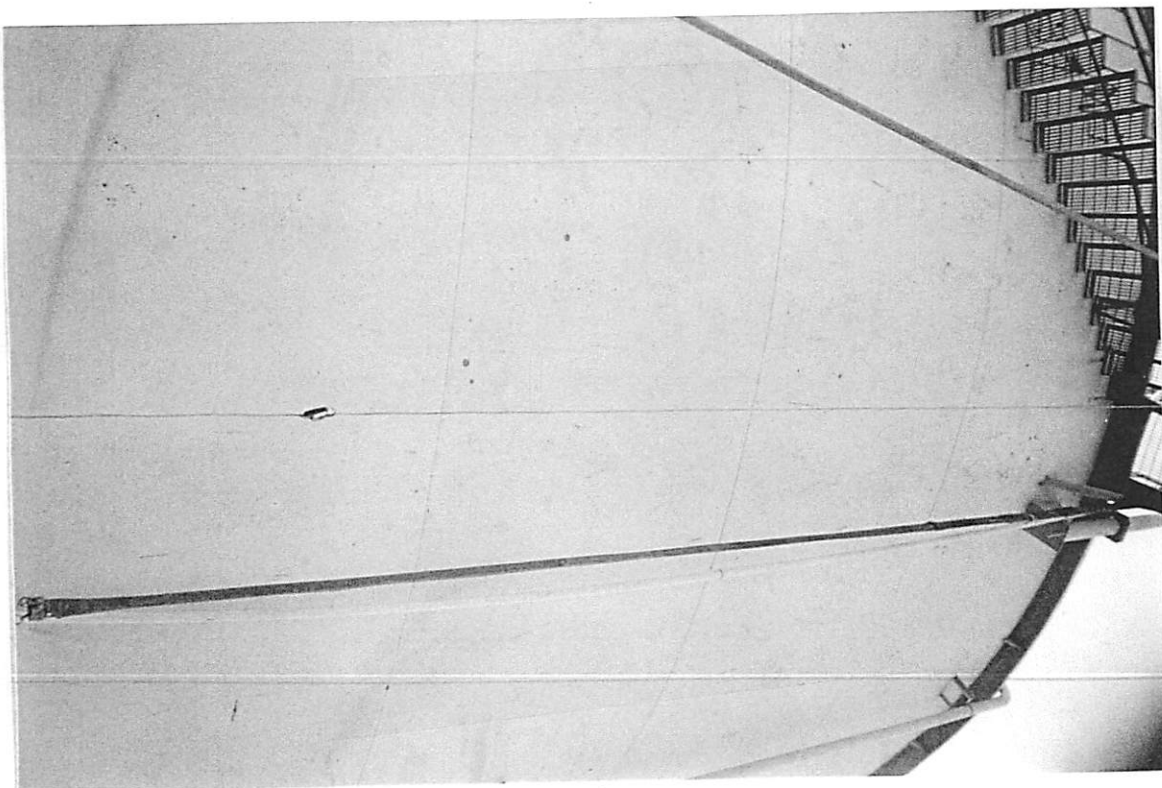
Photo 2. Flexhouse going up and into above ground storage tank.  
Photo taken by Shawn Blocker, U.S. EPA  
8/17/2004

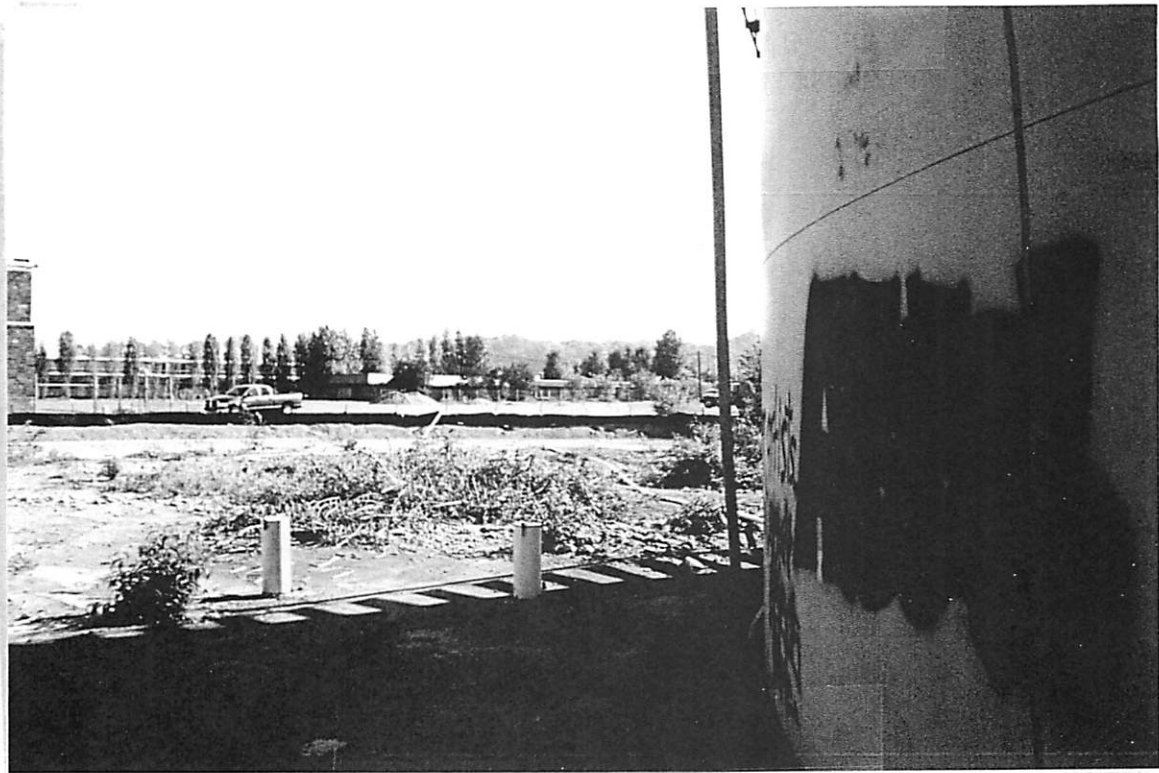
3. Flexhouse going up and into above ground storage tank.

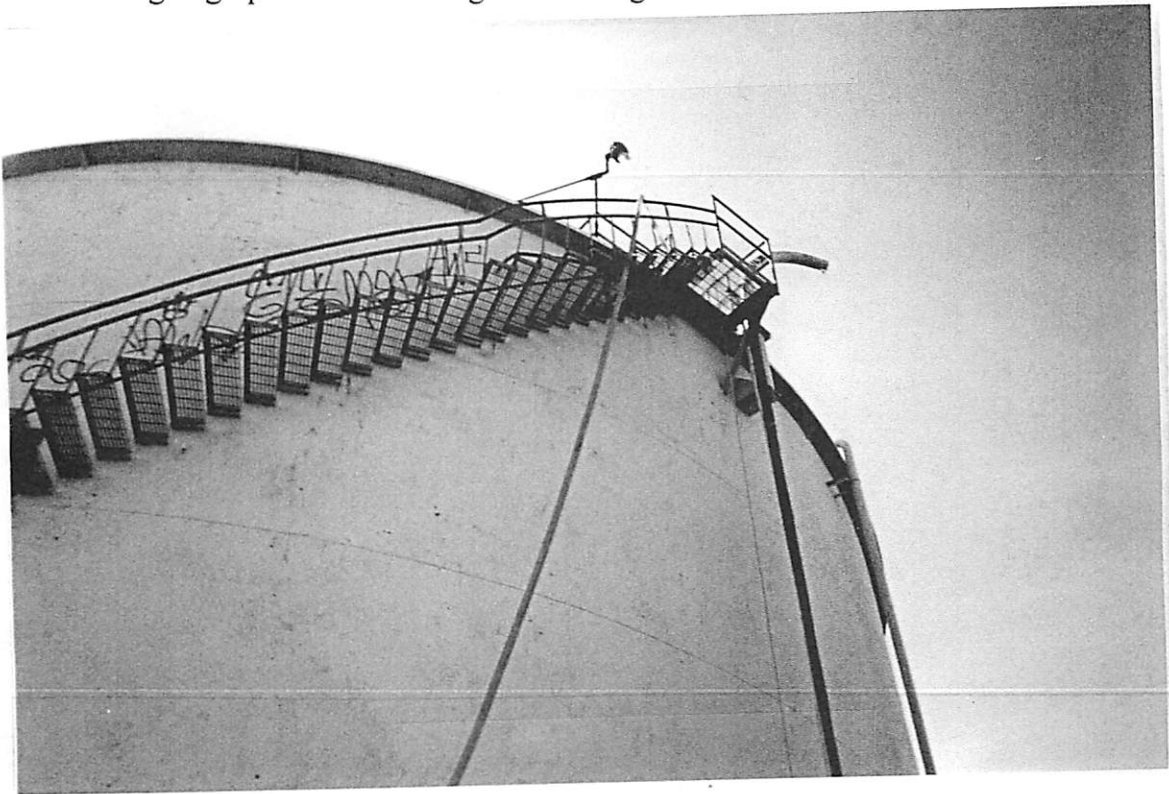
Photo 4. Flexhouse going up and into above ground storage tank.  
Photo taken by Shawn Blocker, U.S. EPA  
8/17/2004

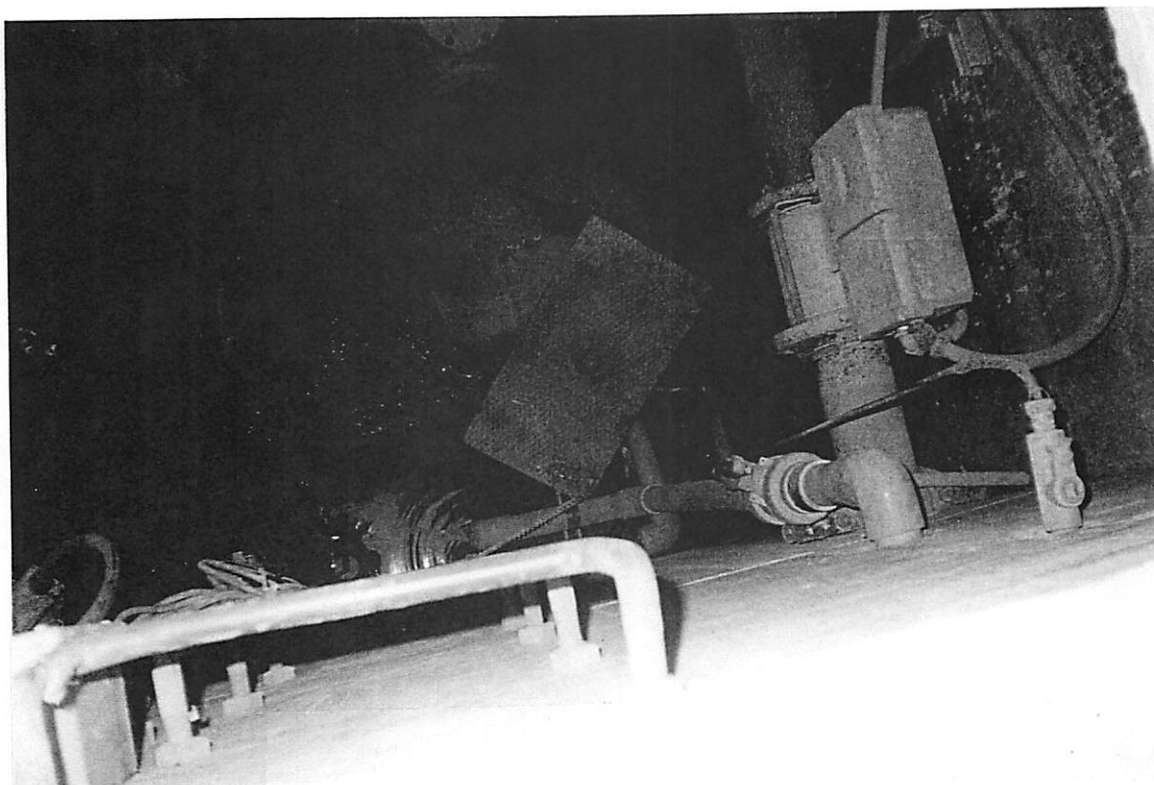
5. Photo inside King County Sewer Lift Station.

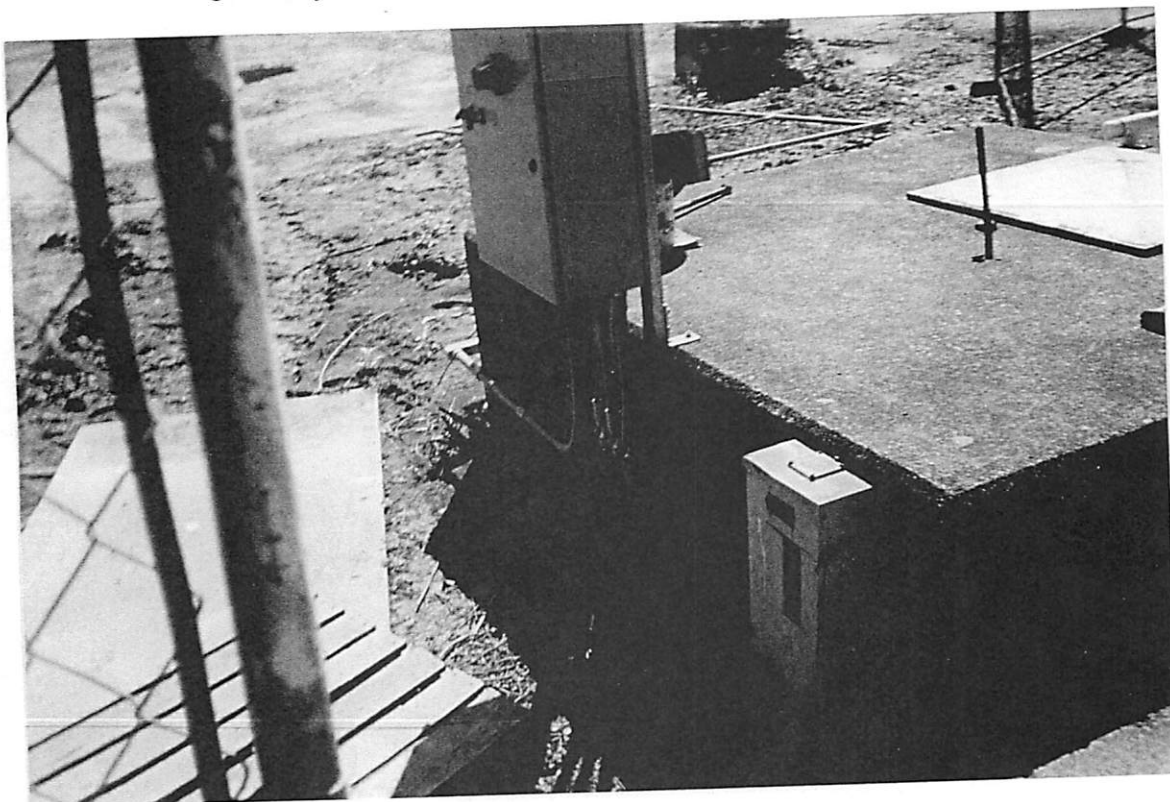
Photo 6. Photo of King County Sewer Lift Station.  
Photo taken by Shawn Blocker, U.S. EPA  
8/17/2004

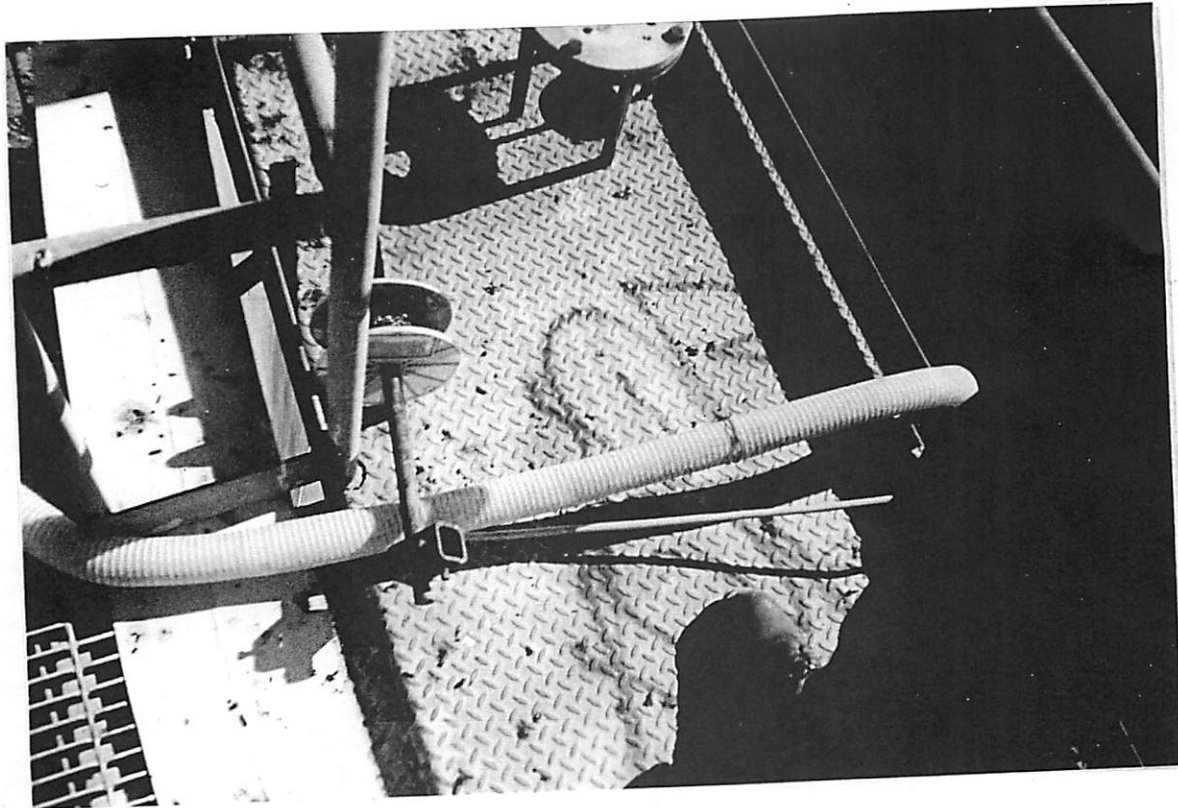
7. Photo of flex hose going into above ground storage tank from the top.

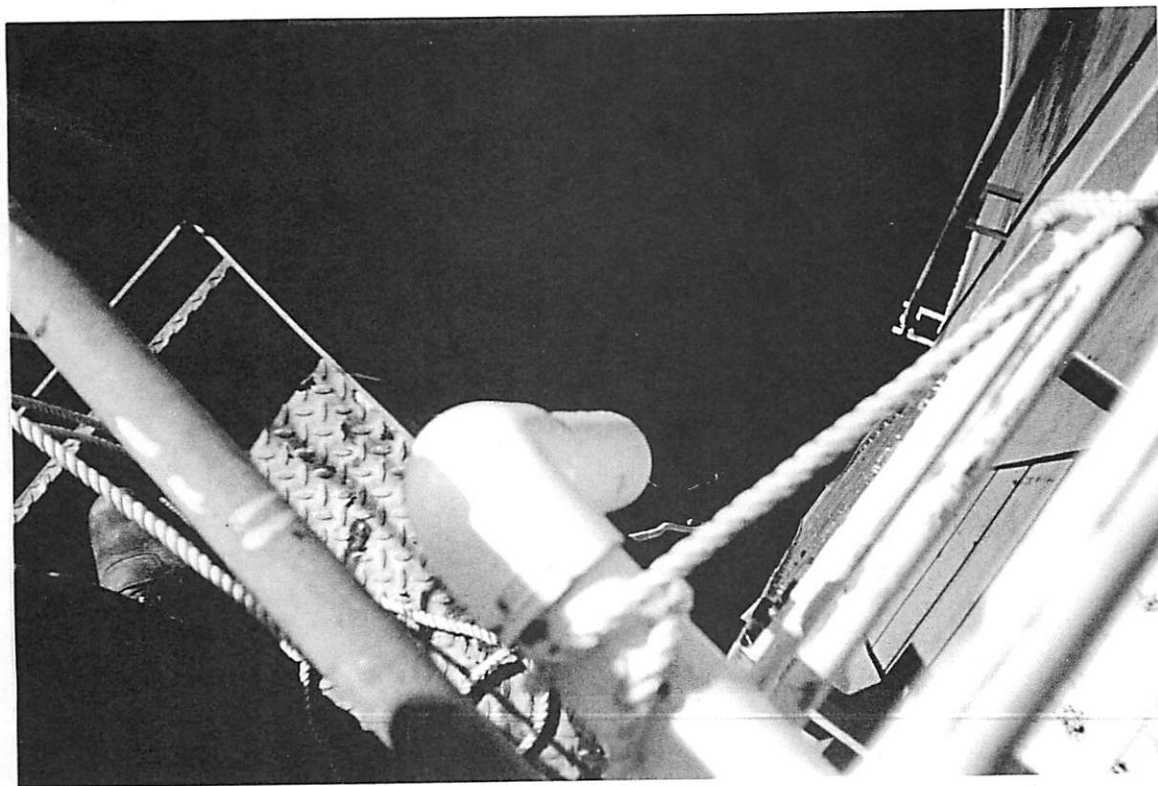
Photo 8. Photo of flex hose going into above ground storage tank from the top..  
Photo taken by Shawn Blocker, U.S. EPA  
8/17/2004

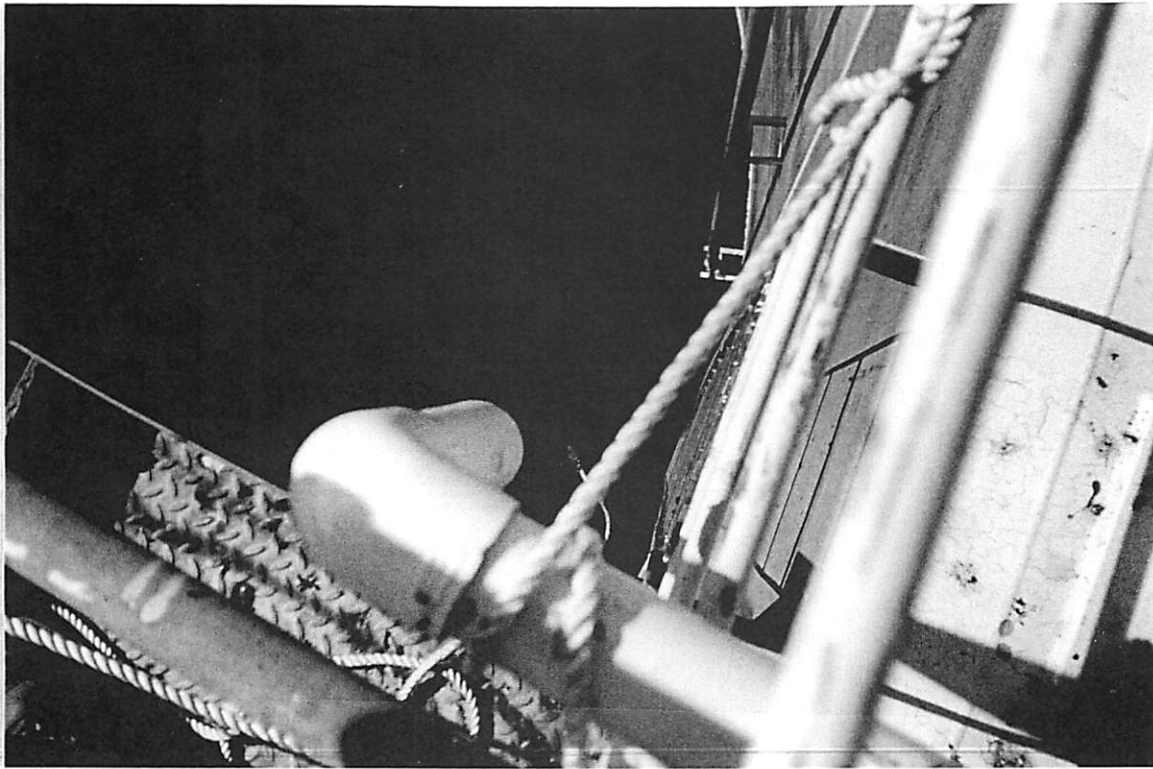
9. Photo of hose going into above ground storage tank from the top.

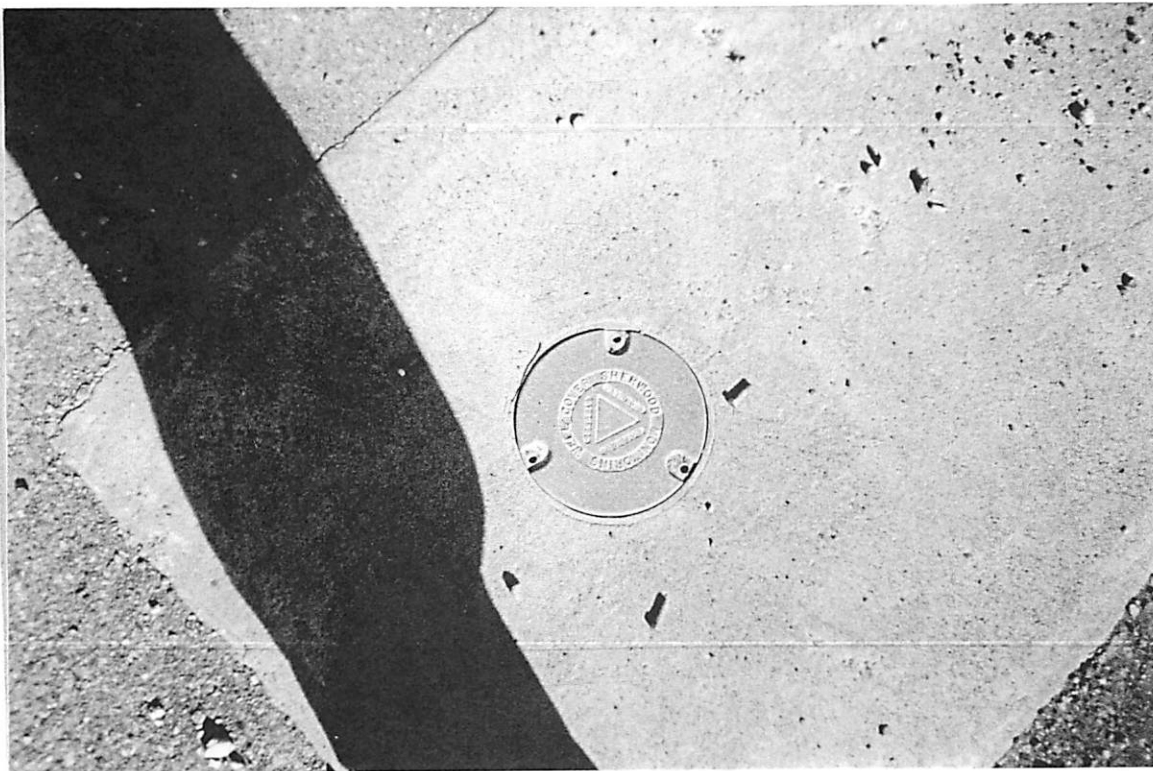
Photo 10. Photo of well cover not properly bolted down.  
Photo taken by Shawn Blocker, U.S. EPA  
8/17/2004

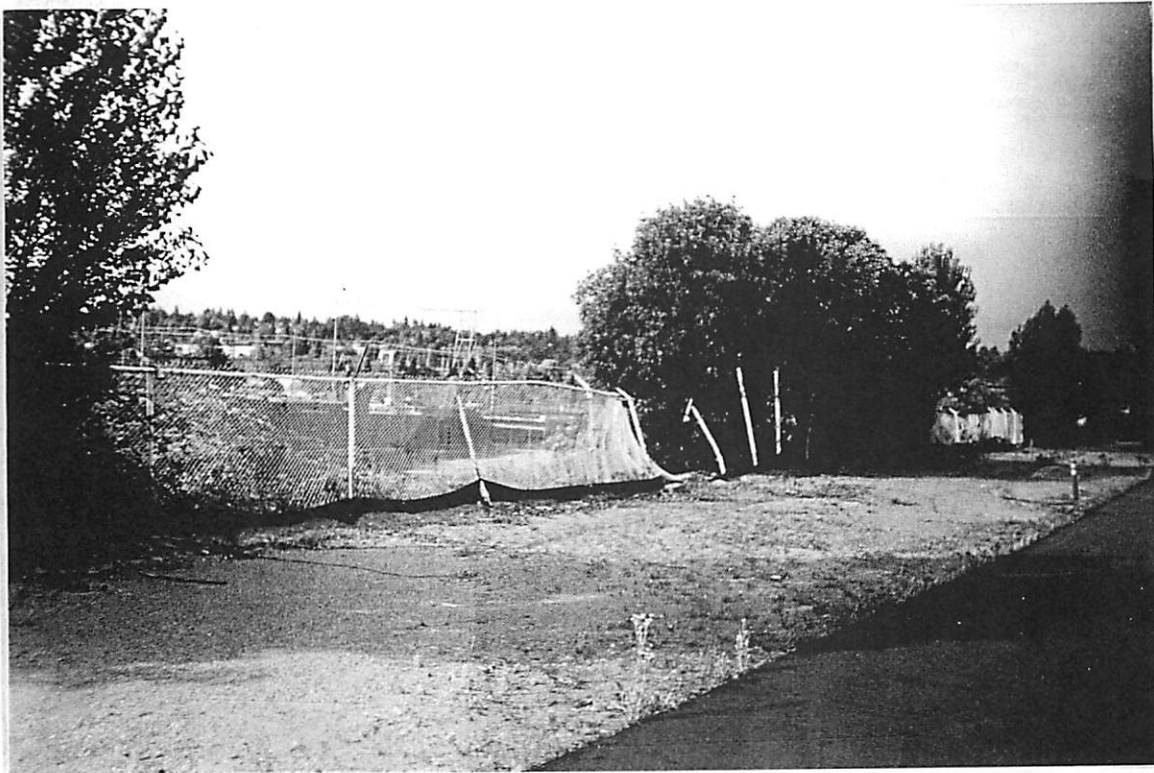
11. Missing fence along slip 6.

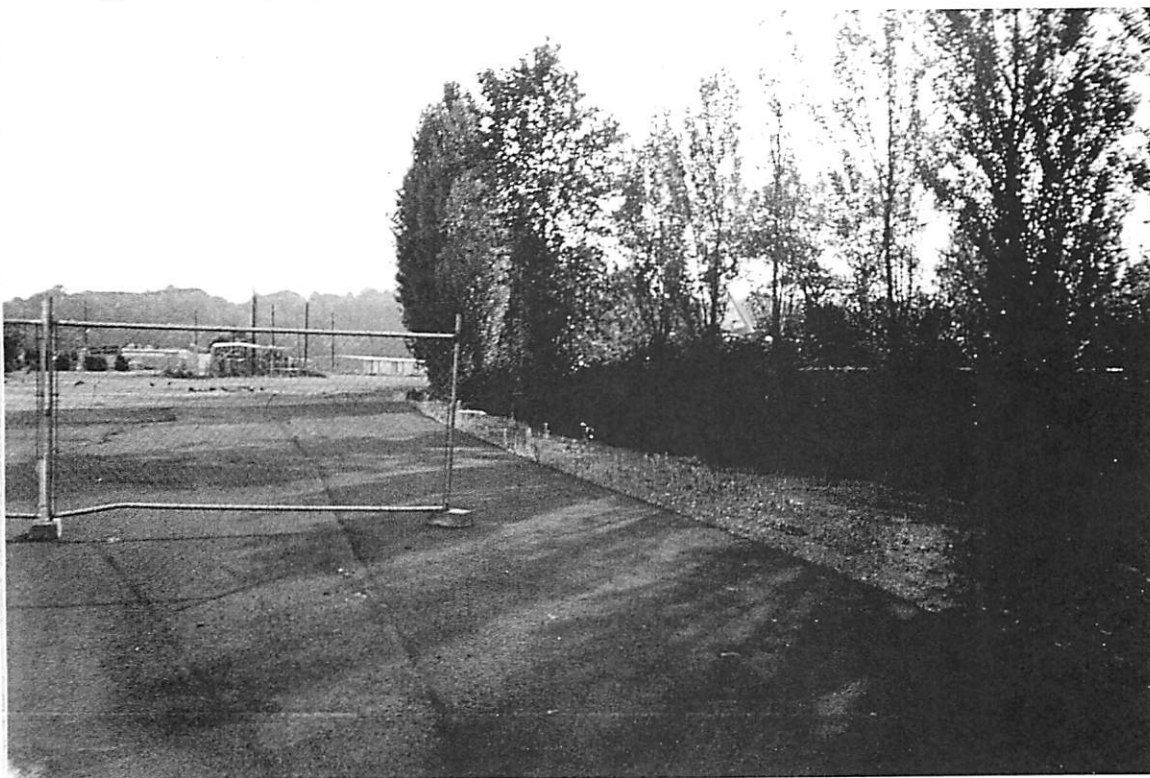
Photo 12. Missing fence in southeast corner of site.  
Photo taken by Shawn Blocker, U.S. EPA  
8/17/2004

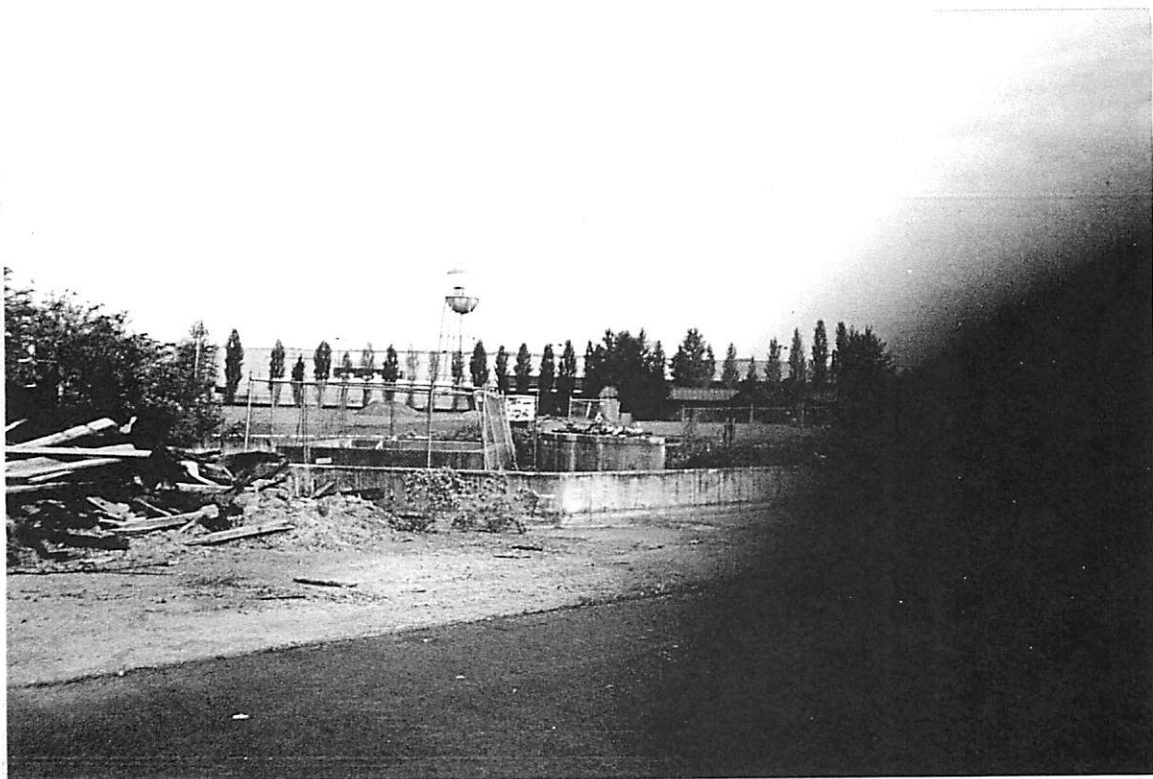
Photo 13. Missing fence near lift station.  
Photo taken by Shawn Blocker, U.S. EPA  
8/17/2004
